**Post-flood analysis of the flood from the rupture of the stone dam
in Rudno nad Hronom on May 17, 2021**

Pavla PEKÁROVÁ*, Pavol MIKLÁNEK, Ján PEKÁR, Jana PODOLINSKÁ

The study is aimed at reconstructing the course of the flood from May 17, 2021 breach of the stone dam in Rudno nad Hronom. Firstly, the volume of water in the reservoir before its breach was determined. The reservoir storage volume was estimated to be 14 807 m³. Then, we focused on the analysis of the hydrological regime in the wider Rudniansky Brook region. In order to derive the flood wave course from the rainfall, a series of 15-minute discharge from neighbouring water gauges measured by the Slovak Hydrometeorological Institute were analysed. In analysing the long-term trends of precipitation and temperature series we used data from the Banská Štiavnica meteorological station (period 1901–2020). In the second part, based on several field measurements after the flood event, we estimated the peak flows of floods from May 17, 2021 above the reservoir and under the reservoir. One hundred meters above the reservoir culmination reached 7.8 m³ s⁻¹, under the reservoir it was between 80 to 100 m³ s⁻¹. Finally, we recons

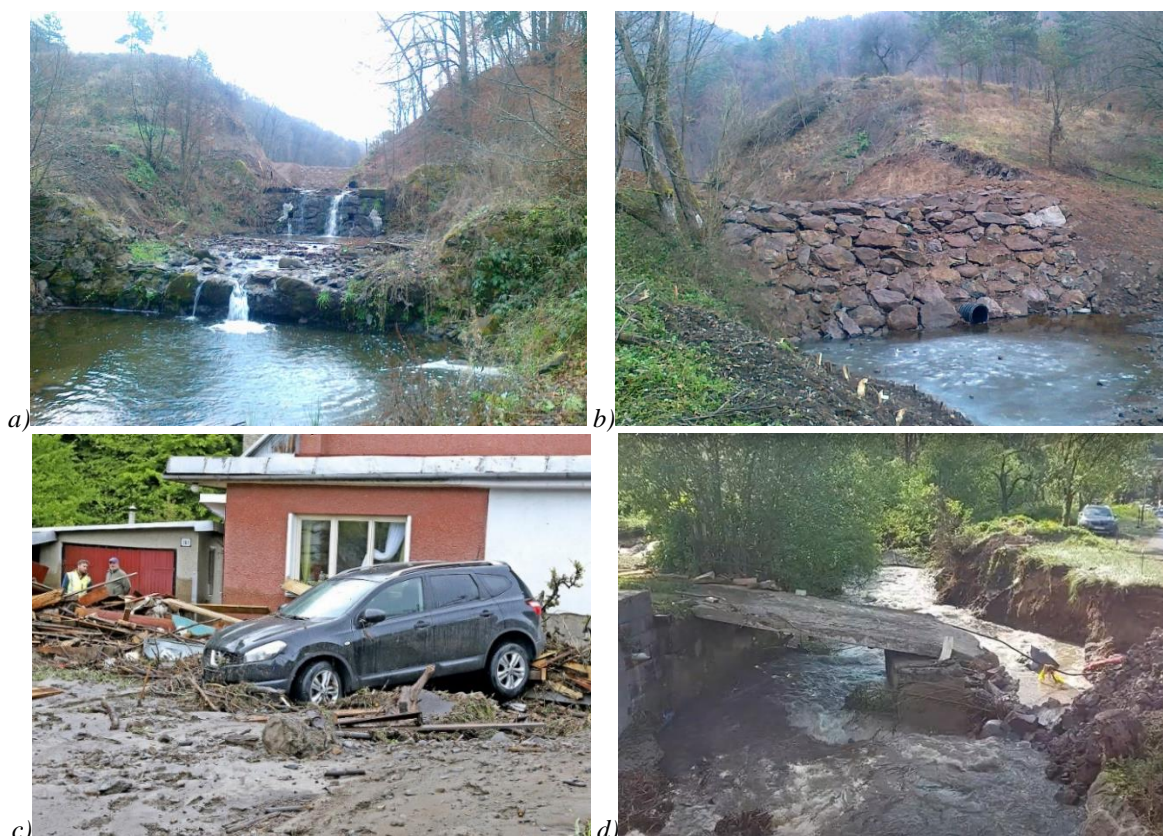
In December 2011, a permeable unpaved stone dam was completed in the place of the original dam of the ruptured New Tajch just above the village of Rudno nad Hronom (Fig. 2 a–b). This was intended to catch extreme flood waves. The crown elevation of the dam was 280 m. The catchment area above the reservoir is 12 km². According to the available information, the new retention area of the dry polder was ca. 29 680 m³ in front of a stone dam 10 m wide, 6 m high, and 22 m long with a DN 800 bottom outlet 32 m long (Hrib, 2012). The stone dam broke and washed away on 17.5.2021 at the time after 15.30 hrs. by the flow of water from the continuous rain. The breakthrough wave that occurred after the break of the dam in the village Rudno nad Hronom caused great material damage (Fig. 2c, d).

Fig. 2. a) Two concrete stone dams downstream the reservoir near Rudno nad Hronom. b) Unpaved permeable 6 m high stone dam built in 2011 in the place of the former 17 m high dam of the New tajch, picture taken from the side of the reservoir (Photo Hrib, 2012). c–d) Flood damages in the village Rudno nad Hronom. The water level height of the flood on 17. 5. 2021 at 18.15 hrs. is visible on the house wall (Photo <https://www.youtube.com/watch?v=5SWMHLeao1s>).

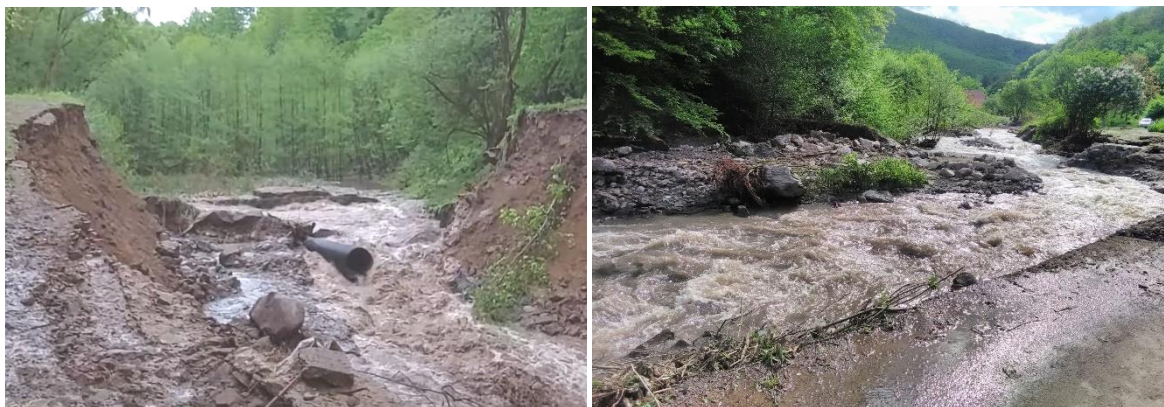
a)–b) Surface runoff after the breakthrough wave on May 17, 2021 at 18.15 hrs.
(Photo from <https://www.youtube.com/watch?v=d2bixIHpRbs>)

Fig. 4. Runoff from the rainfall wave downstream the reservoir after the breakthrough wave.

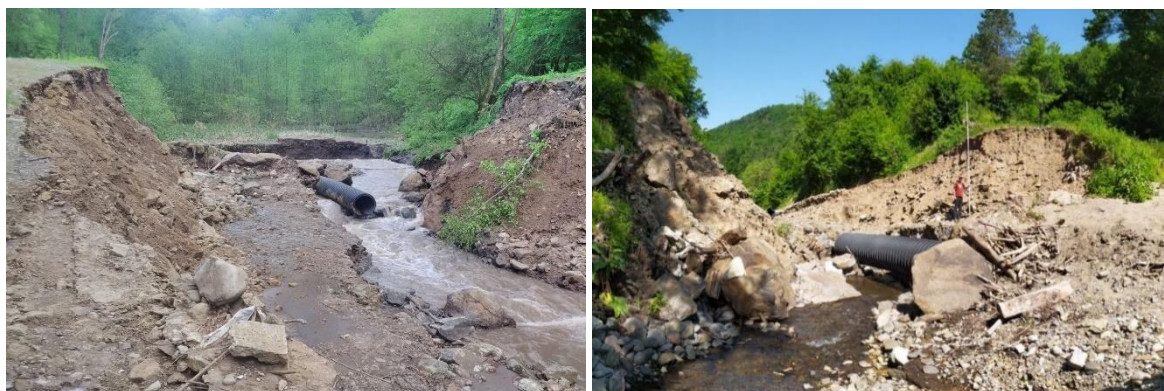
c) Surface runoff on May 18, 2021 at 16.20 hrs. d) Clogged pipe from the bottom drain on June 8, 2021.
(Photo Mészáros, Pekárová)

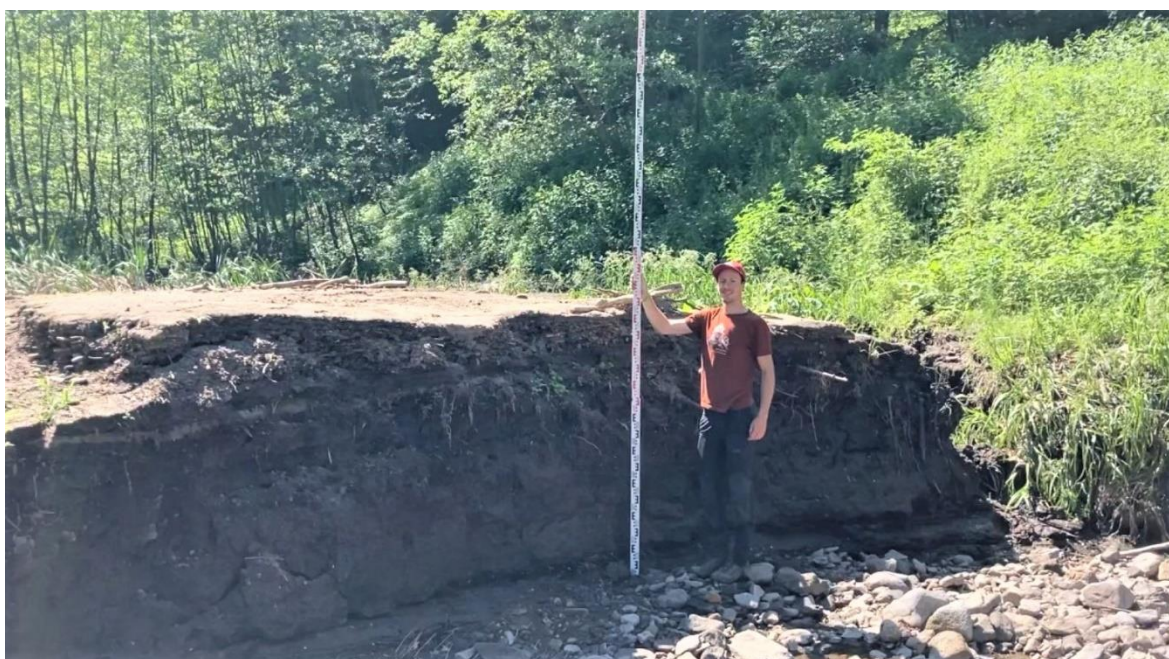
In the flood wave volume calculations, it was necessary to find the volume of water that flowed out of the reservoir after the dam broke (Pekárová et al., 2021a). It was not possible to work with the 2011 reservoir volume figure (ca. 30 000 m³), as the bottom of the reservoir has been covered with sediment for more than 10 years (Fig. 5). The thickest sediment deposits we measured in the field were about 1–1.7 m high.

Fig. 5. Thickness of 10 years sediments at the reservoir bottom at Rudno nad Hronom.
(Photo Pekárová, 8. 6. 2021).

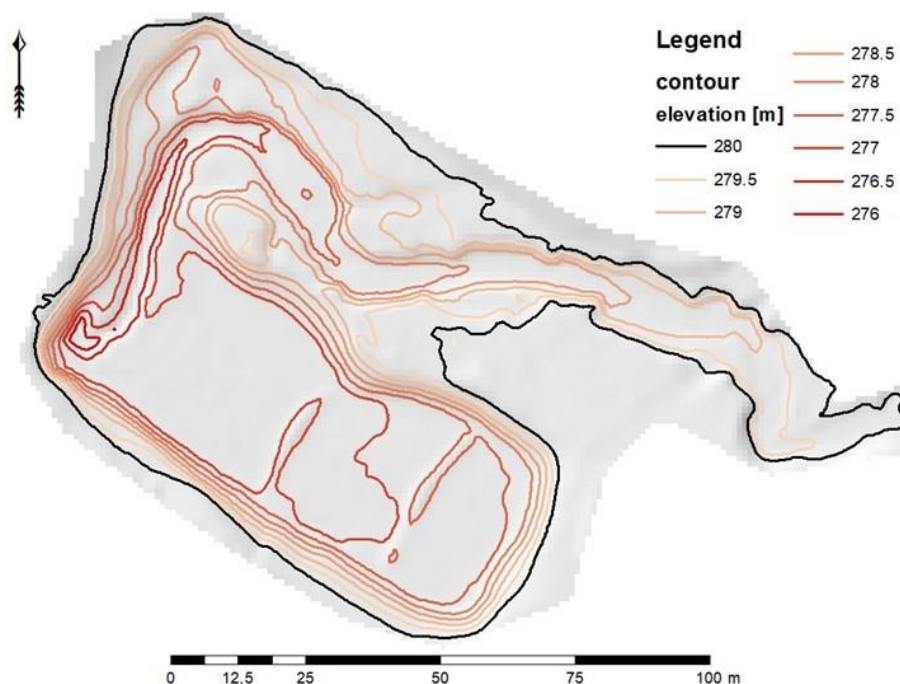
section was clipped with a contour with an elevation of 280 m (Fig. 6). We obtained the DMR of the empty water reservoir. With the Surface Volume tool, the reservoir storage volume in 2019 was calculated to be 14 807 m³, which is about half of the volume given by the project author more than 10 years ago.

Fig. 6. Water reservoir in 2019.

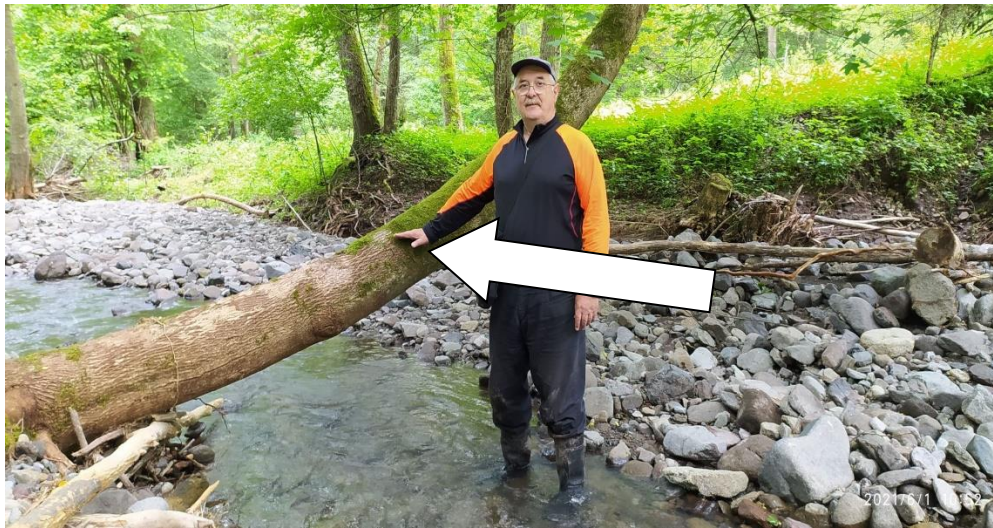
The profile 100 m above the reservoir (48.4191300N, 18.7049519E) was selected to determine the peak discharge by hydrotechnical calculation (Fig. 9). In this profile (Fig. 10a), the flow area at the estimated

Fig. 9. Traces of the flood (Photo Mészáros, 1.6. 2021).

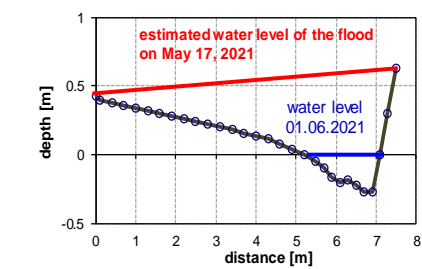
a) Rudniansky brook

Fig. 10. a) Cross-section of the Rudniansky Brook based on field measurements, 100 m upstream the reservoir. (Roughness coefficient = 0.028; stream slope 0.023). b) Cross-section of the Rudniansky Brook about 70 m downstream the reservoir dam.

The peak discharge of the May 17, 2021 rainfall flood event in the profile 100 m above the reservoir was estimated to be $7.8 \text{ m}^3 \text{s}^{-1}$, i.e. $650.2 \text{ l s}^{-1} \text{ km}^{-2}$. Similar to the neighbouring streams, the flood wave from the rain peaked around 17.00 hrs. CEST. In determining the average profile speed, we were based on the assumption of steady uniform water movement, in which the slope of the water level is parallel to the slope of the bottom.

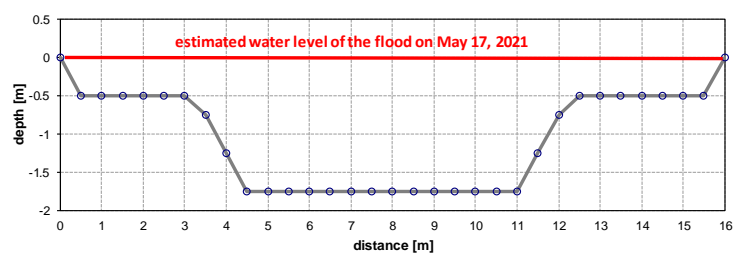
b) Rudniansky brook

The profile of the old solid concrete and stone dam below the destroyed spillway was selected to determine the peak discharge from the breakthrough wave below the dam (Fig. 10b). The peak flow was estimated based on the surveyed cross-sectional area and the estimated water velocity to be $90 \text{ m}^3 \text{s}^{-1}$.

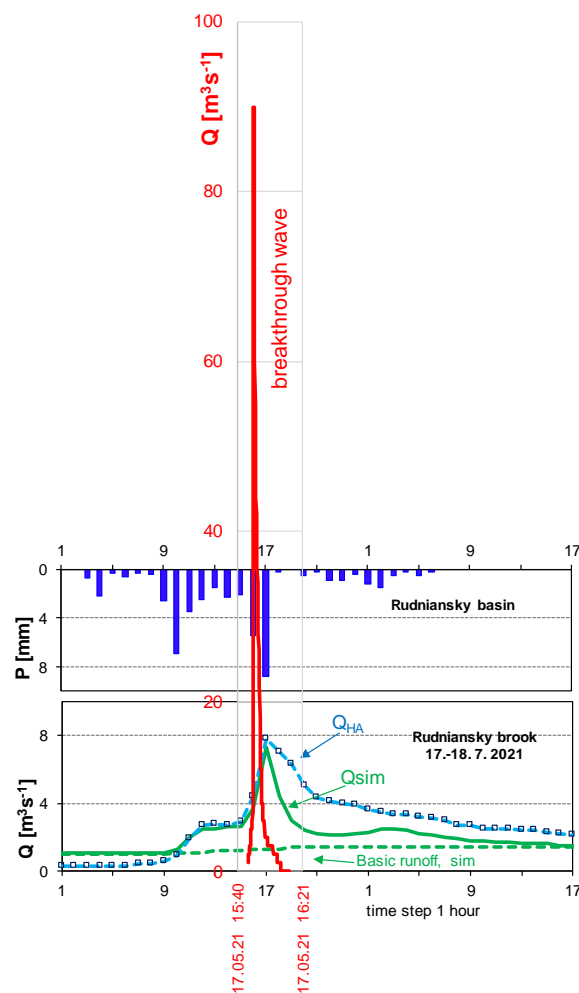
Fig. 11. Scheme of the reconstructed rain flood wave Q_{HA} – by hydrologic analogy (blue) and simulated Q_{sim} – by NLC model (green) downstream the reservoir on 17. 5. 2021. The breakthrough wave (red). The breakthrough wave and the rain flood wave have different scales on both x and y axes.

The course of the breakthrough wave from the reservoir water just below the dam was determined to be triangular in shape so that the peak reached $90 \text{ m}^3 \text{ s}^{-1}$ and the volume was $15,000 \text{ m}^3$. The breakthrough wave has an extremely high flow rate on the one hand and a very short duration on the other. Its course is schematically indicated in red in Figure 11.
