# ACTA HYDROLOGICA SLOVACA

Volume 24, No. 1, 2023, 14 – 23

# Characterization of leakage water flows in the subsoil of Beni Haroun dam by hydrogeological approach

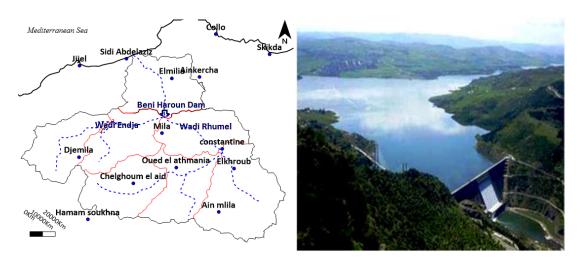
Fig. 2. Watershed and downstream view of Beni Haroun dam (Chebbah and Kabour, 2018).

The structure is of the rectilinear weight type, in BCR (Roller Compacted Concrete) (Fig. 2), with a crest length of 710 m, levelled at elevation 216.3 m, an order height of 118 m above the foundations, and the direction of the axis of the dam is approximately North to South. The lake of the reservoir hugs the captured part of Oued El Kebir and the two valleys of Oued Rhumel and Oued Endja, on a surface of 39.29 km², that is to say nearly 4 000 ha. The rainfall-reservoir balance makes it possible to determine a net destocking by evaporation, equivalent to an average annual tranche of 350 mm. The reservoir can store 963 hm³ of water, i.e. a useful volume of 732

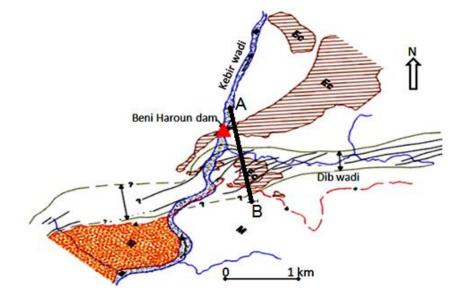
Fig. 3. Geological map of the site (Harza, 1984).

The local geology is part of a complex tectonic context of thrusting and faults or detachments, characterised by plastic deformations (folding) and brittle deformations (faults, fractures) of the lithological units of the site. These units are schematically made up of a competent limestone base (with rigid – brittle – behaviour) from 100 m to 150 m thick, framed by two incompetent marl series (with plastic – folded – tectonised – behaviour) (Fig. 3 and 4) (Mebarki and Benabbes, 2008). This basic tectonic architecture, already complex in

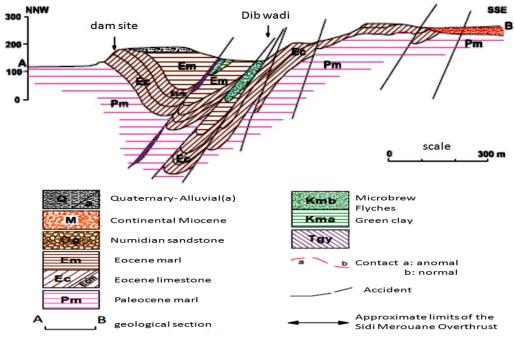
Fig. 4. Geological cross section in the Beni Haroun dam site (Harza, 1984).

20 boreholes were drilled during the first phase (1984) by Harza Engineering, and during the second phase in 1997, the remaining 12 boreholes were drilled by Tractebel. The borehole logs were used to draw geological cross-sections (Fig. 4) (Kebab et al., 2021).

itself, is complicated by the presence of faults with a strong north-north-west plunge (shear zones) and North-South fractures (observed in the dam foundation). There is every reason to believe that these are traction fractures linked to the torsion of the limestone banks mentioned. (Fig. 4) (ANBT, 2007).

The limestones have a synclinal structure, the dam being entirely founded on its northern flank. Along the left bank of the reservoir, extend into a boat shape, the limestone banks have a sub-vertical or even slightly upward plunge (towards the interior of the slope), and are therefore subject to mowing (or rocking of the heads of the layers). This gravitational phenomenon results in a progressive dislocation of the rock, until it develops into an instability of the settlement, rockfall or landslide type, such as that observed just upstream of the dam (mirador landslide). These phenomena of superficial stretching of the rock mass are accompanied by an opening of the fracture systems, and therefore by a strong increase in permeability (Fig. 4) (Kebab et al., 2021).

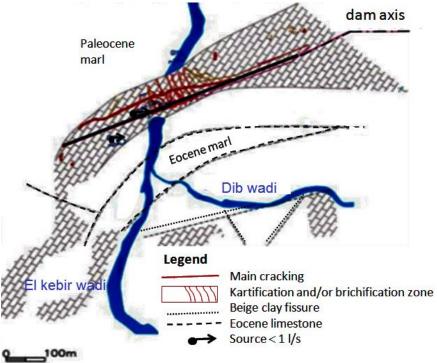
Fig. 5. Location of the karst aquifer (ANBT, 1999).

decimetric to metric thickness, it is dark grey to black with a micrite texture (fine grain). The Ypresian limestone is hard to very hard and weather resistant, because some layers are dolomitic or even siliceous, while the other layers contain black flint (ANBT, 2002). Examination of the drill cores recovered during the investigation phase revealed some traces of karst dissolution in this limestone bedrock; these traces of karst developed mainly along certain sub-vertical joints. The opening of the karstified zones could reach 30 to 50 cm. However, during construction, all karst problems were treated by grouting (Fig. 5) (ANBT, 2002).

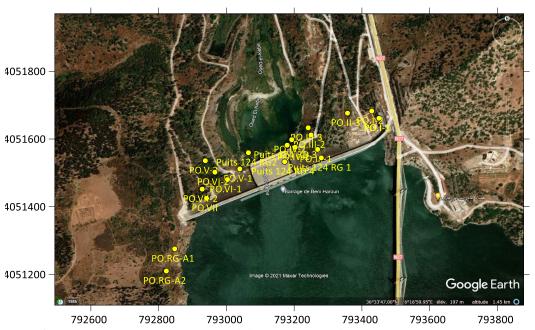
Fig. 6. Location of piezometers around the Beni Haroun dam.

The piezometers installed in the Beni Haroun dam site show a piezometric control of the reservoir lake in relation to the limestone aquifer on the left and right banks and in the syncline (Fig. 6).

The water level in the piezometers located in the right bank (piezometers, POI 1, POIII 1, POIII 2, POIII 3, POIV 1) (Fig. 6) showed a good correlation (R<sup>2</sup> between 0.557 and 0.608) with the water level in the reservoir (Fig. 7), from the graphs (Fig. 7) we notice an average correlation between the studied parameters, and also that the slope of the regression lines undergo an increase for all the concerned piezometers which indicates a strong water circulation which is due either to the entrainment of the clogging materials by the flow created by the hydraulic load, or to the chemical dissolution of the components of the rock mass (Toumi and Remini, 2018). But for the piezometers (PUIT 124 RD3, PUIT 124 RD4, POIV 2, PO II 3, POI 2) we have a weak correlation (R<sup>2</sup><0.304), which allows us to see that there is no water circulation between the lake and the piezometers, and that the slopes of the regression lines undergo a rather increasing variation, which indicates the existence of water circulation under

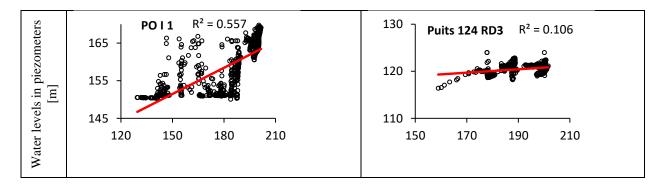
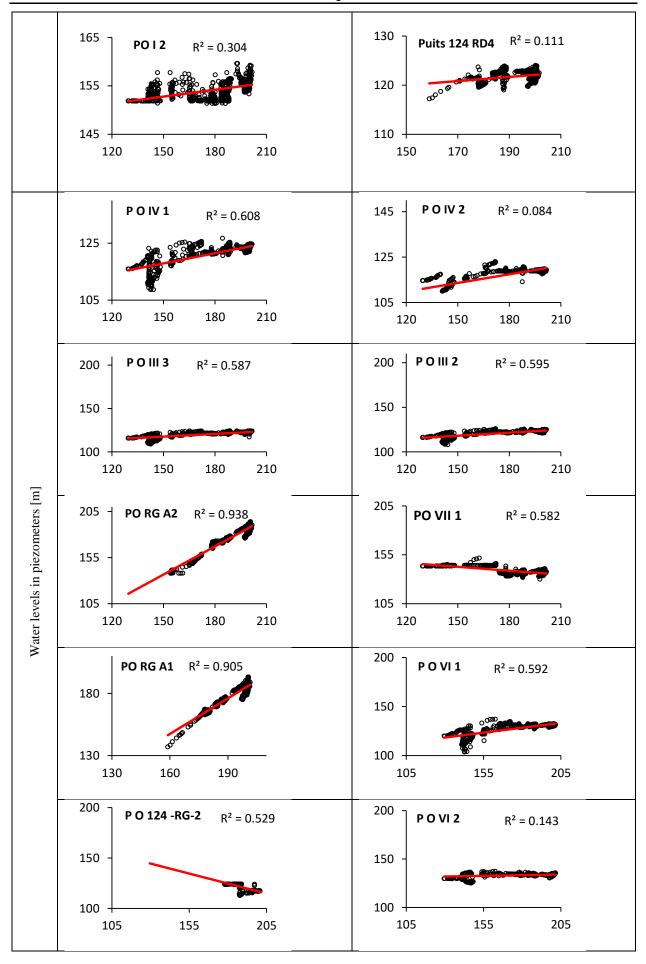
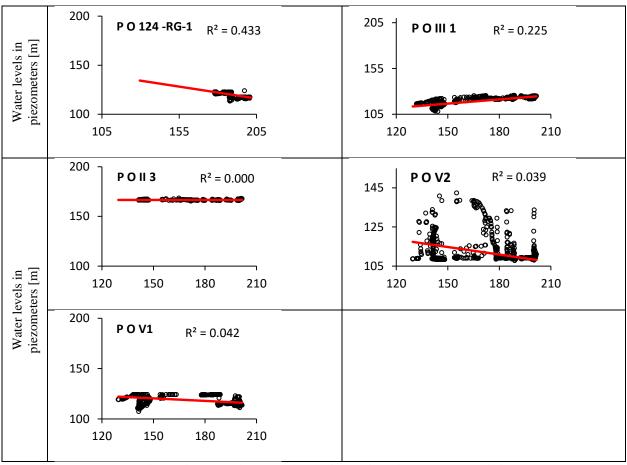
Fig. 7. Correlation between the water level observed in the reservoir and that of the piezometers around the Beni Haroun dam (2003–2021).

Monitoring data from the piezometers over the period (2003–2021) have clearly shown the performance of the various seepage control measures (Fig. 7).

For the piezometers located on the left bank, a strong correlation is recorded (PO RG A2 and PORG A1) ( $R^2>0.9$ ); for the piezometers located upstream of the dam axis, a good correlation is observed for PO VII 1 ( $R^2=0.582$ ), for PUITS 124 RG 2 ( $R^2=0.529$ ) and for PO VI 1 ( $R^2=0.952$ ).

For the rest of the piezometers (POV 1, POV 2, POVII 2, POVI 2, PO 124 RG 1), a very weak correlation (R<sup>2</sup><0.4) between the parameters presented is noted, which informs us of the absence of water circulation in the zones located between the lake and these piezometers (Fig. 7).

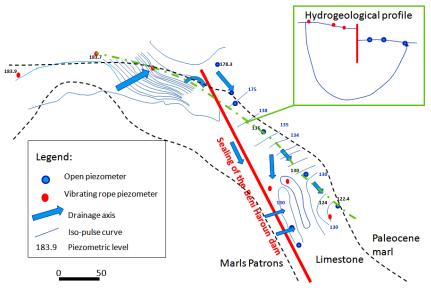
Fig. 8. Groundwater flow in the limestone aquifer during dam construction (ANBT, 1999; Benchabane, 2015).

The synclinal structure has a steep western termination, marked by the limestone outcrops on the left bank. Gravity flow has been able to exploit submeridian discontinuities in these limestones to bypass the marly core of the syncline (Fig. 8) (ANBT, 1999). Circulations are fed in a concentrated way under the alluvium of the left bank. They follow two types of drainage axes: firstly, the contact between the limestone wall and the Paleocene black marl to the northwest; secondly, the network of breccias and fracture discontinuities, which jointly direct the gravity flows towards the spring area of the dam site (ANBT, 2007; Benchabane, 2015). The installation of the dam caused the karst aquifer discharge threshold to rise from 105 m, the approximate altitude of the talweg, to more than 200 m, the approximate altitude of the dam's scouring sills (ANBT, 2007).

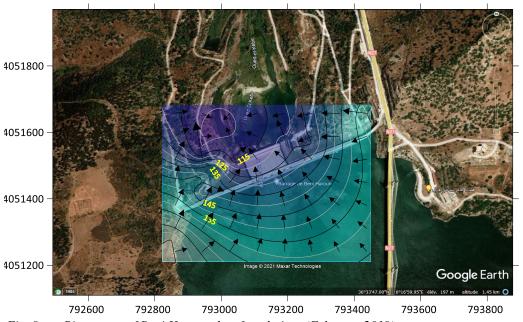
Fig. 9. Piezometry of Beni Haroun dam foundations (February 2019).

There is a slow flow from south to north along the dam from a level of 135 m to 115 m (Fig. 9). On the right bank the flow direction is East-West towards the river. From the piezometric data, it can be seen that, even if the water level in the reservoir increases, the water level in most of the piezometers does not move, except for small disturbances during the rainy seasons (Fig. 9). In piezometers POI1 and POI2 a different response is observed, i.e. the water level is higher than in the other piezometers, and the level rises at the time of flooding, which means that there is a relationship with rainfall and that infiltration is rapid in limited areas. On the left bank, the curves are tight with a South East-North West flow direction, which indicates the existence of a rapid flow from a water table (fissured limestone) and the lake water. A hydraulic gradient likely to maintain underground circulation between the lake the downstream side of the dam, which is expressed preferentially on the left bank. This bank presents a remarkable differentiation compared to the right bank, this difference is located at the level of the piezometers PORG A1, PORG A42 where the water level in these

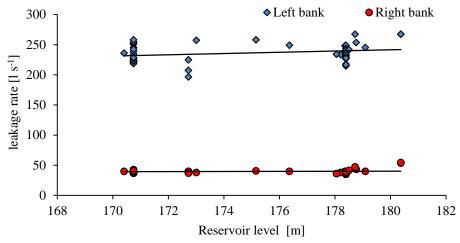
Fig. 10. Variation of leakage rates as a function of reservoir elevation.

Conversely, for the same hydraulic load, flows can increase if there is a decrease in head losses following geometric and morphological modifications of the fractures. These modifications can have two origins; either erosion or entrainment of clogging materials, or chemical or mechanical erosion of the rock matrix (Labadi and Achour, 2011). The correlation of the seepage rates at the shoreline with the lake level (Fig. 10) clearly shows that the seepage rates increase strongly with the load and this for a lake level of about 178 m, for the left shore. For the right bank, the variation

of the lake level has no influence on the leakage rates on this bank, and they are stabilised around a value of 40 and  $50\,1\,\text{s}^{-1}$ .

It can also be seen that the leakage flows in the left bank are greater than those from the right bank, and there is no relationship between the leakage flows from the right bank and the left bank (Fig. 10).
