## Evaluating flood events caused by Medicane “Daniel” in the Thessaly District (Central Greece) using remote sensing data and techniques

Evangelos LEIVADIOTIS\*, Silvia KOHNOVÁ, Aris PSILOVIKOS

KEY WORDS: flood, Medicane Daniel, Thessaly, remote sensing, damage assessment, Sentinel-1

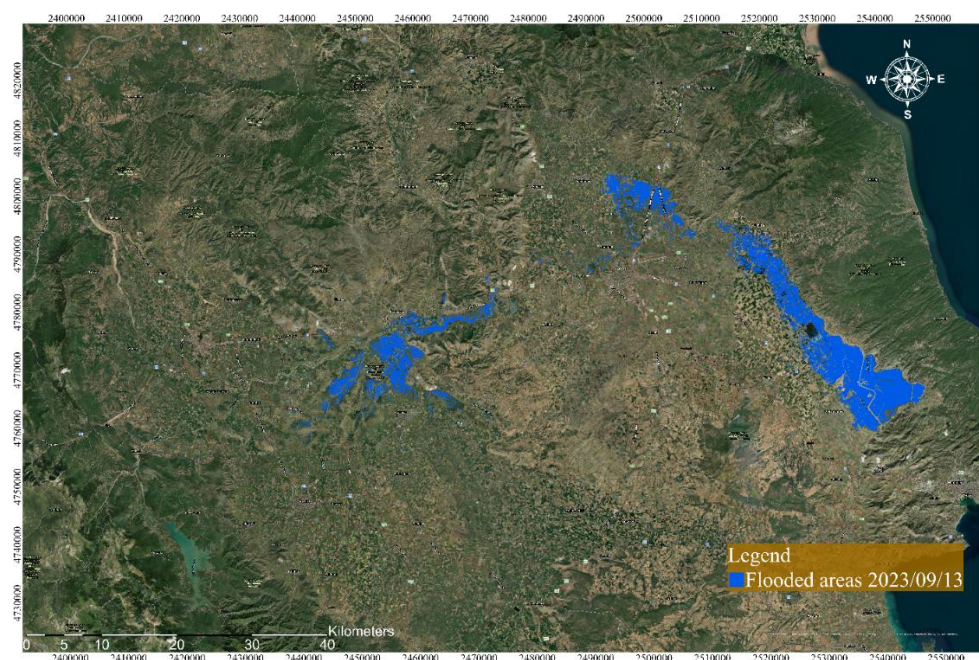
Fig. 6. Map of Thessaly's inundates areas, September 13, 2023.

the greatest extent of the flooding, which covered 516.52 km<sup>2</sup> and extended from western to eastern Thessaly. After three days, on September 13, 2023, the flooded areas derived from the Sentinel image showed a significant decrease, covering 169.70 km<sup>2</sup>; it was primarily located in Eastern Thessaly at Lake Karla (Fig. 6).

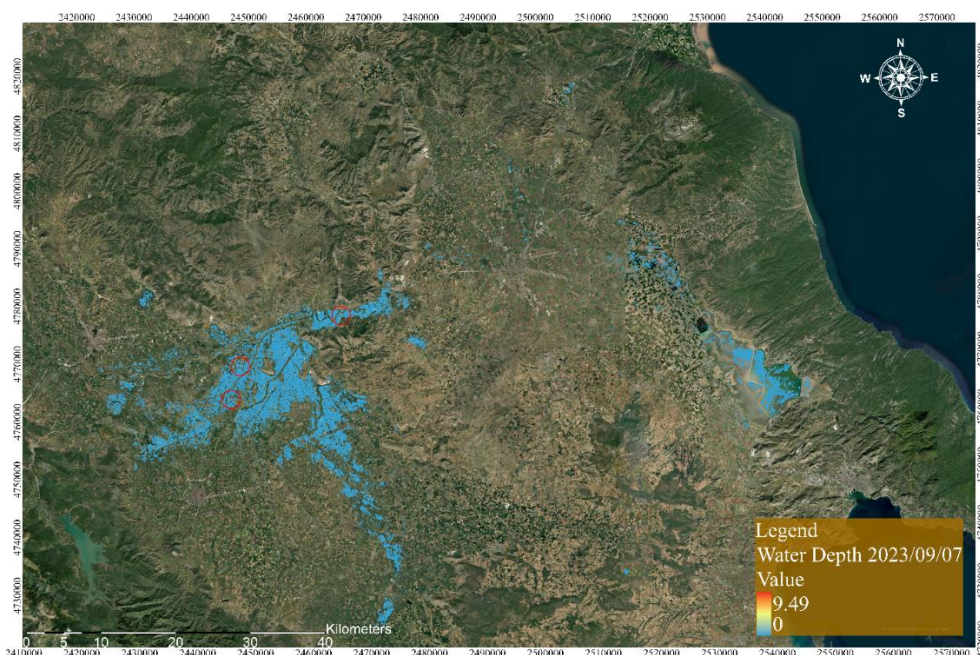
Fig. 8. Distribution of flood water depths estimated by the FwDET tool (September, 7, 2023, red circles indicate regions of high depth).

The investigation assessed the depth of the inundation at various locations over a specified temporal interval. The initial observations from Fig. 5 delineated a discernible trend in the floodwater depths, indicating an increase from September 7 to 10, 2023, followed by a gradual decline until September 19, 2023. Specifically, on September 7, 2023, the maximum inundation depth reached 9.49 m, with notable concentrations near riverbanks denoted by red circles within the Western
