**Post-flood analysis of the flood from the rupture of the stone dam
in Rudno nad Hronom on May 17, 2021**

Pavla PEKÁROVÁ*, Pavol MIKLÁNEK, Ján PEKÁR, Jana PODOLINSKÁ

The study is aimed at reconstructing the course of the flood from May 17, 2021 breach of the stone dam in Rudno nad Hronom. Firstly, the volume of water in the reservoir before its breach was determined. The reservoir storage volume was estimated to be 14 807 m³. Then, we focused on the analysis of the hydrological regime in the wider Rudniansky Brook region. In order to derive the flood wave course from the rainfall, a series of 15-minute discharge from neighbouring water gauges measured by the Slovak Hydrometeorological Institute were analysed. In analysing the long-term trends of precipitation and temperature series we used data from the Banská Štiavnica meteorological station (period 1901–2020). In the second part, based on several field measurements after the flood event, we estimated the peak flows of floods from May 17, 2021 above the reservoir and under the reservoir. One hundred meters above the reservoir culmination reached 7.8 m³ s⁻¹, under the reservoir it was between 80 to 100 m³ s⁻¹. Finally, we recons

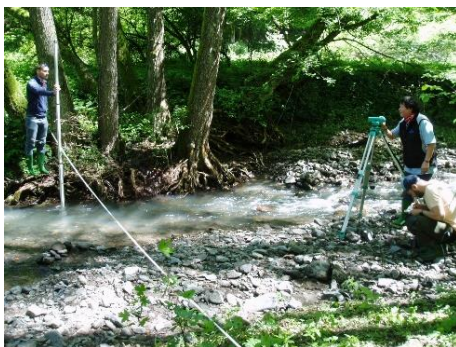
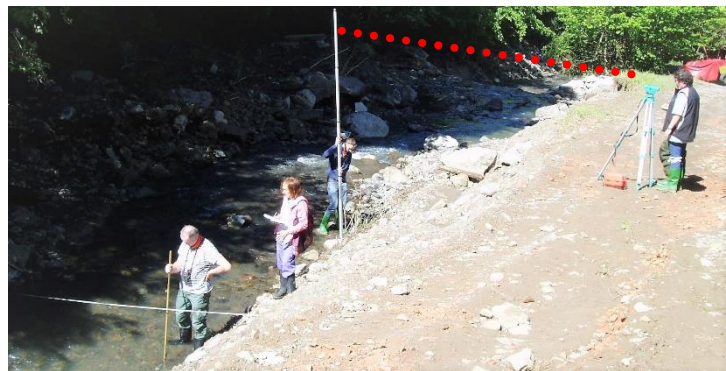
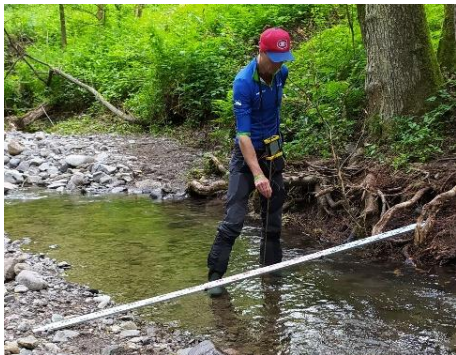
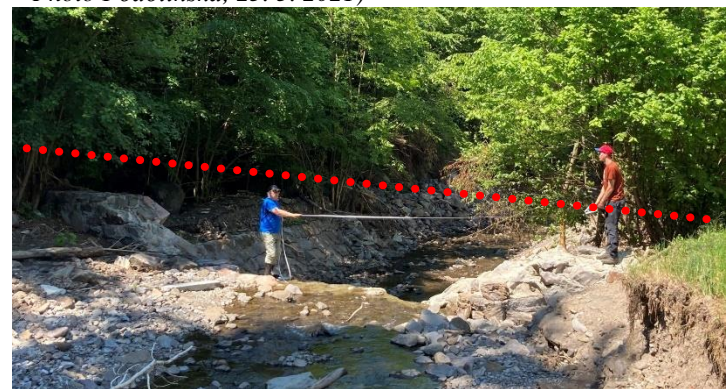
Fig. 10. a) Cross-section of the Rudniansky Brook based on field measurements, 100 m upstream the reservoir. (Roughness coefficient = 0.028; stream slope 0.023). b) Cross-section of the Rudniansky Brook about 70 m downstream the reservoir dam.

The profile of the old solid concrete and stone dam below the destroyed spillway was selected to determine the peak discharge from the breakthrough wave below the dam (Fig. 10b). The peak flow was estimated based on the surveyed cross-sectional area and the estimated water velocity to be $90 \text{ m}^3 \text{s}^{-1}$.
